PUBLIC ROADS

VOL. 9, NO. 3 MAY, 1928

THE CONNECTICUT AVENUE EXPERIMENTAL ROAD

A DISCUSSION OF CONSTRUCTION AND MAINTENANCE METHODS AND PRESENT CONDITION OF VARIOUS TYPES OF SURFACE LAID IN 1911, 1912, AND 1913

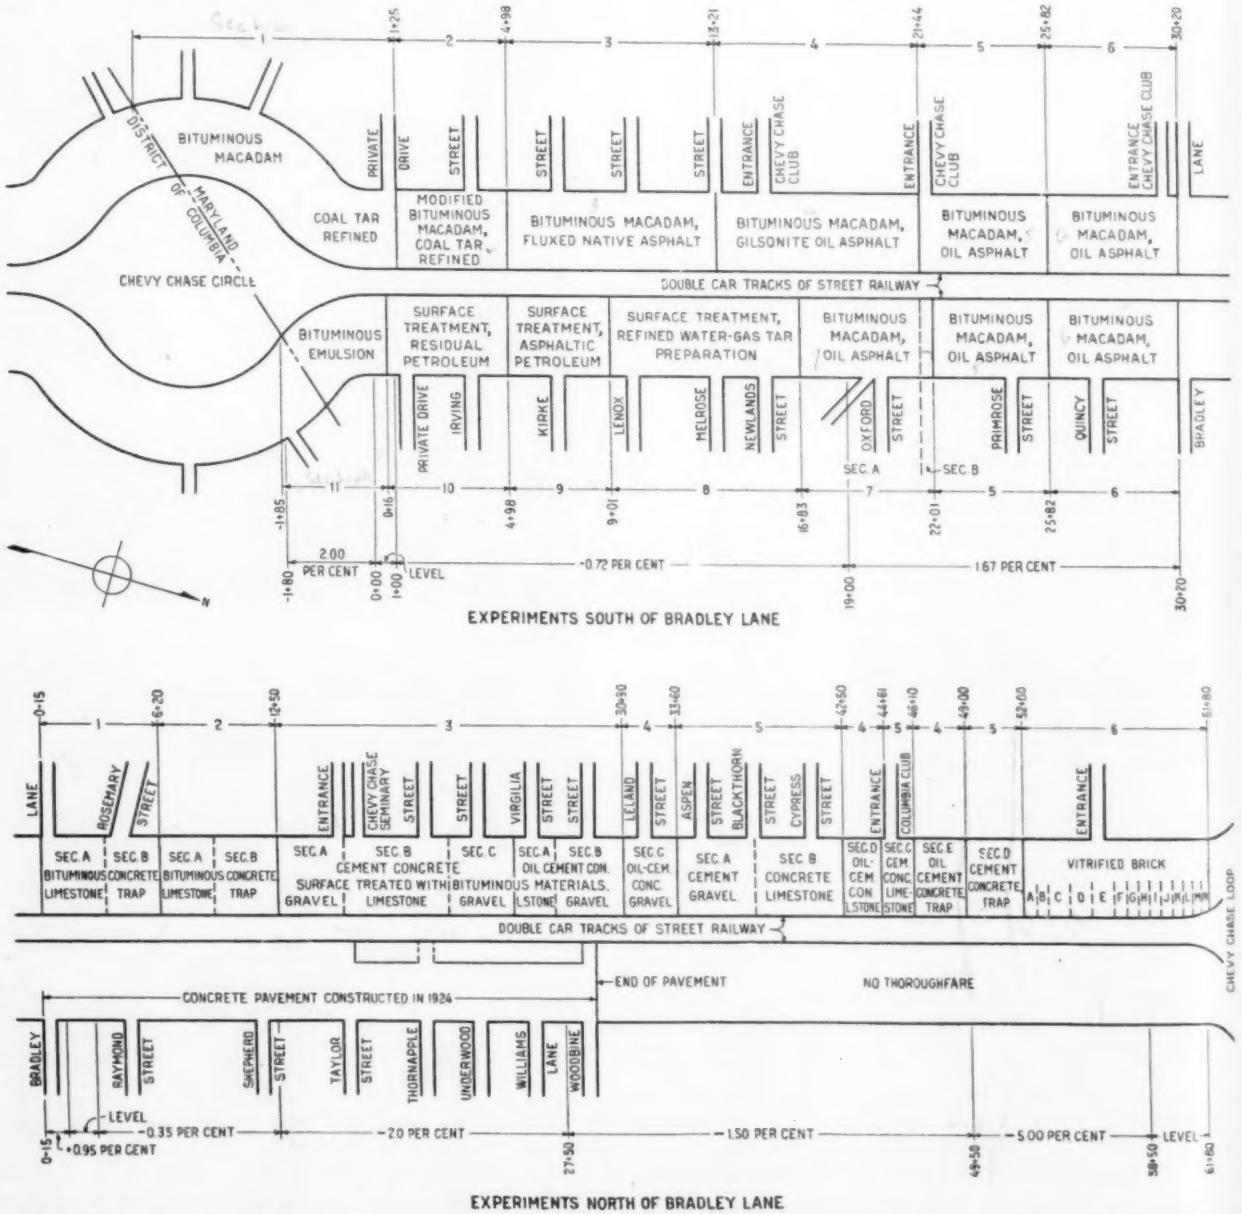
Figure 1 shows the location, grade, and nature of the experimental sections. As indicated, a double-track street railway divides the thoroughfare. At the time of construction the east side of Connecticut Avenue was not improved north of Bradley Lane, consequently the north experimental sections were subjected to traffic traveling in both directions, whereas, those lying south of Bradley Lane have carried only one-way traffic. In 1924, with the extension of the pavement on the east side from Bradley Lane to Woodbine Street, experiments 1, 2, and most of 3 of the north group were relieved of the northbound traffic. However, the remainder of experiment 3 and all of experiments 4, 5, and 6 still carry traffic in both directions.

FIG. 1.—LOCATION OF VARIOUS EXPERIMENTAL SECTIONS. THE GRADES ARE APPROXIMATELY THE SAME ON BOTH SIDES OF THE TRACKS AND THOSE DESCENDING TOWARD THE NORTH ARE SHOWN AS NEGATIVE

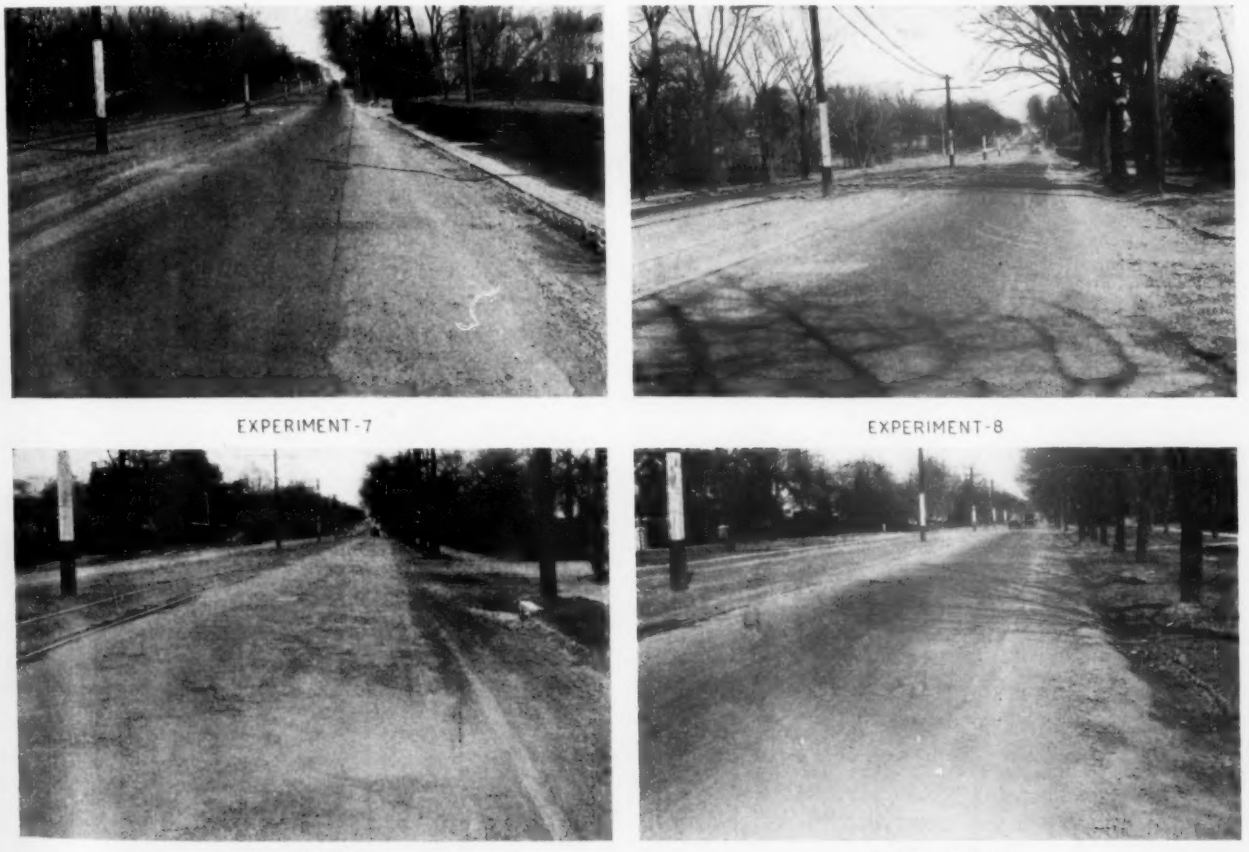
Within a year after construction the binder appeared to be lifeless. It was considered also that the asphalt used was too hard and had a melting point too high for this type of construction. A number of worn depressions occurred in both sections A and B, although to a much greater extent in the single-application area. These defects were repaired and a surface treatment of 0.29 gallon of cold asphaltic oil and one-half inch stone was applied to the patches on section A and to the whole of section B. This treatment undoubtedly saved section B from total failure.

Subsequently section A required considerable patching and section B developed many short irregular waves. These waves have not, however, developed serious roughness although considerable cracking has occurred on a 3-foot strip adjacent to the car tracks. At the present time the appearance and condition of this section compares favorably with the other experiments of this group, although the maintenance costs for the past few years have been somewhat higher than the average.

CONDITION OF PENETRATION MACADAM (EXPERIMENT 7) AND THREE PENETRATION MACADAM SECTIONS IN 1928

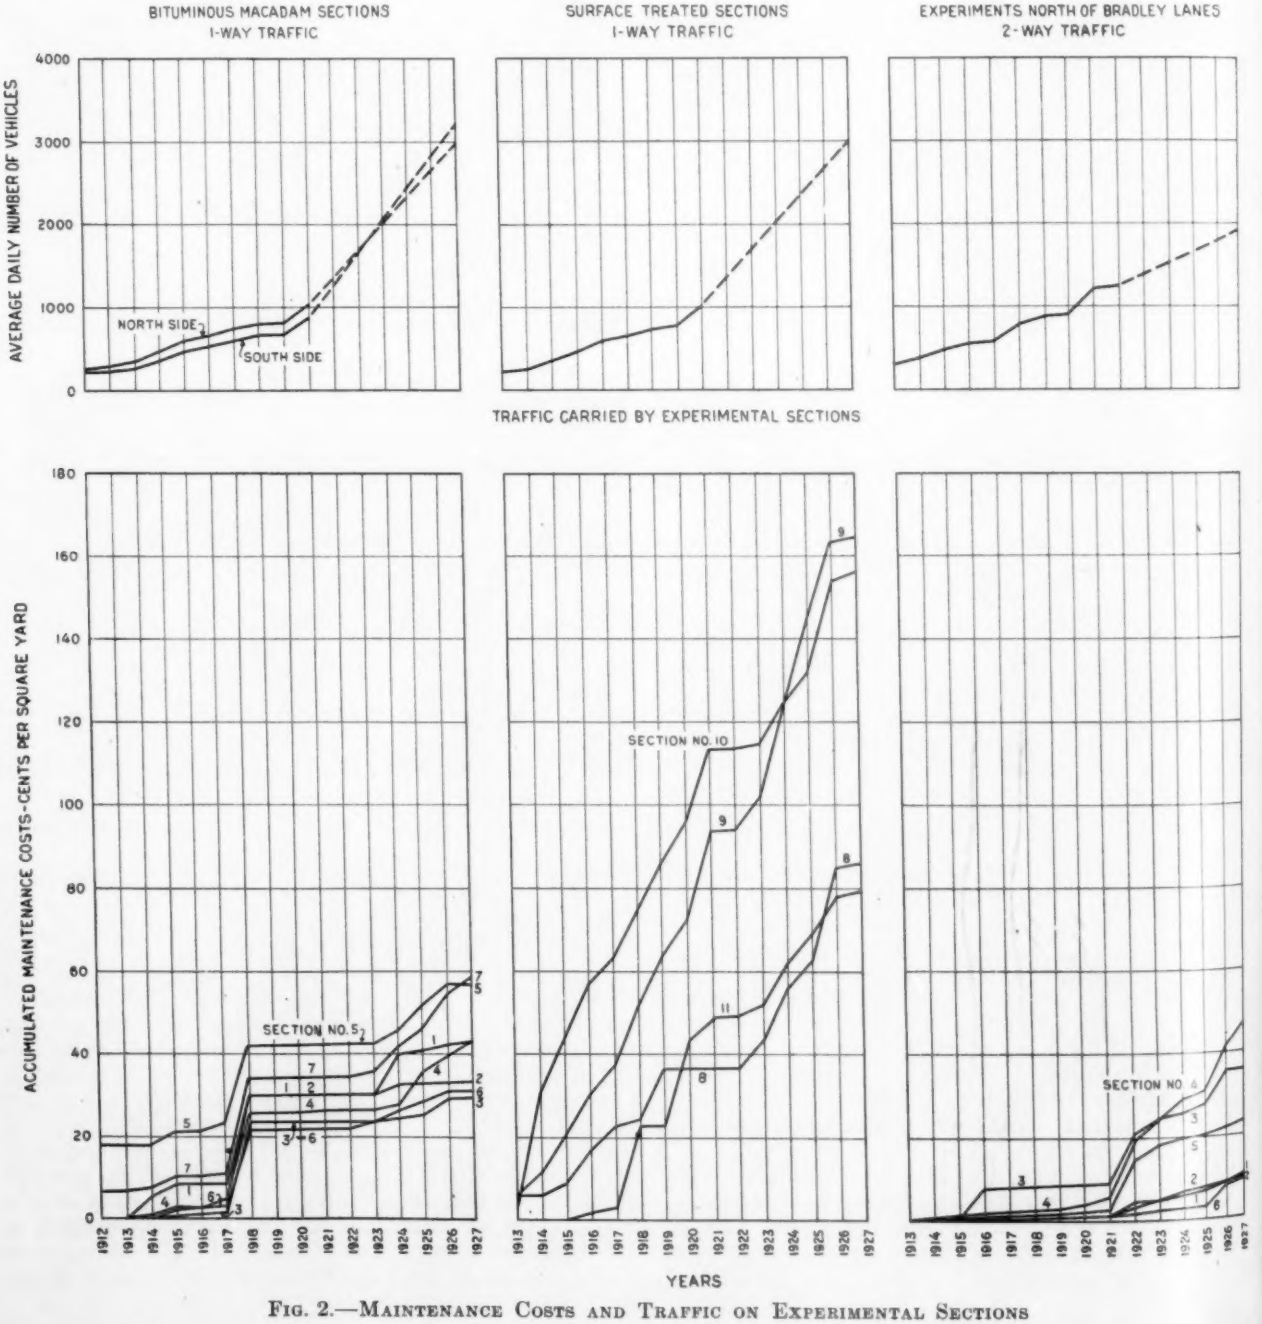
As might be expected the cost of maintaining the bituminous macadam surfaces (shown in Table 1 and fig. 2), has proved to be far less than the costs on the three strictly superficial bituminous treatments on waterbound macadam. For the former the average yearly maintenance cost for the 16 years since construction has been 2.60 cents per square yard as compared to 8.30 cents per square yard on experiments Nos. 8, 9, and 10 over a period of 15 years. Experiment No. 8 of the surface-treated group has proved more economical than experiments Nos. 9 and 10, but nevertheless its average annual maintenance costs have been more than double the average of those on the bituminous macadams. The bituminous grouted section, No. 11, partakes more of the nature of the bituminous macadam than of the

surface treatments. However, as it is not closely related to any type at present being constructed, its costs are omitted from this comparison. Yearly maintenance costs and traffic on the experiments south of Bradley Lane are shown graphically in Figure 2.

FIG. 2.—MAINTENANCE COSTS AND TRAFFIC ON EXPERIMENTAL SECTIONS

The accumulated maintenance costs of the six sections north of Bradley Lane are given in Table 1, and the costs by years are shown graphically in relation to the traffic in Figure 2.

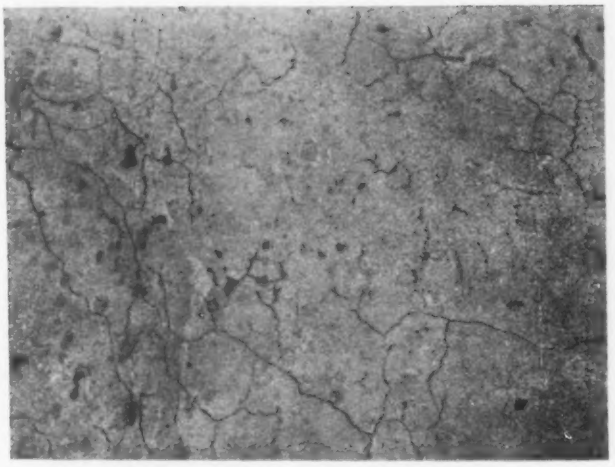
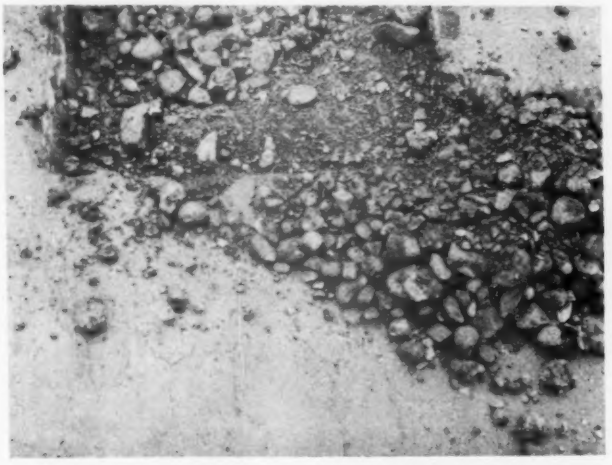
On a number of scattered areas in the limestone section, especially near the west edge, the surface has been broken by the formation of fine irregular cracks. These areas have remained firm and smooth and have required no additional maintenance up to this time. However, it may be reasonably expected that they will eventually affect the life of the pavement and will require more maintenance.

A BADLY CRACKED AREA OF BITUMINOUS CONCRETE IN EXPERIMENT 1, NORTH OF BRADLEY LANE. THE LOWER PICTURE SHOWS THE CONDITION OF THE CONCRETE BASE WHICH COULD BE REMOVED WITH A SHOVEL

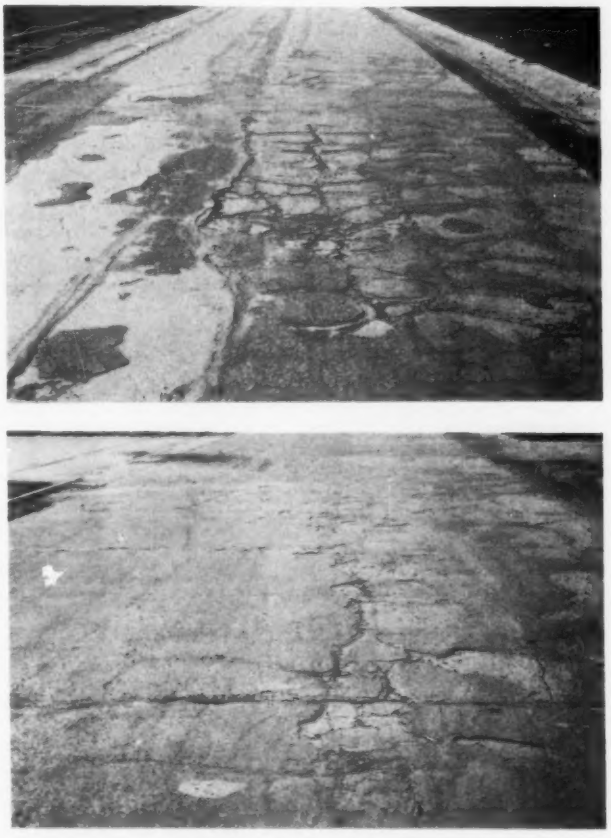
All the sections in this experiment are in poor condition and will require heavy maintenance from now on. Very little difference in appearance is noted between the gravel and crushed-stone aggregate and between the cement and oil-cement sections.

CONDITION OF SURFACE-TREATED CONCRETE SECTIONS IN 1928, EXPERIMENT 3–B. THE UPPER PICTURE SHOWS CONCRETE NOT CONTAINING OIL AND THE LOWER PICTURE SHOWS OIL-CEMENT CONCRETE

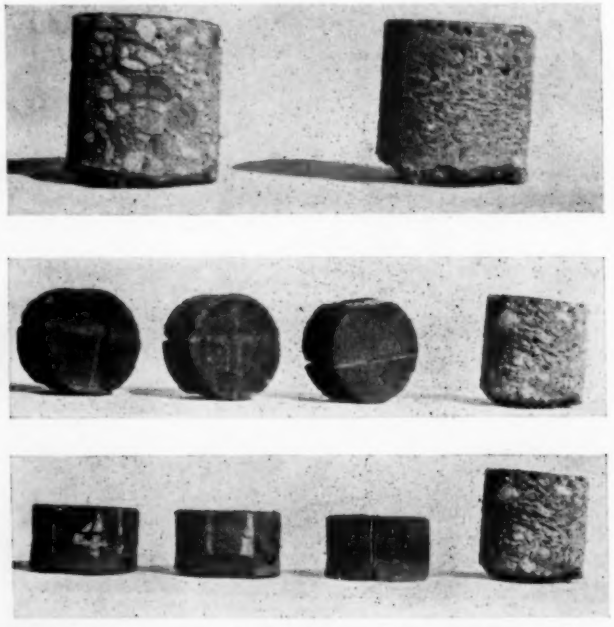
The presence of hydrated lime in portions of the trap rock sections of experiments No. 4 and No. 5 apparently has not affected the behavior of the concrete. Cores were taken both from the badly cracked portions and from the larger areas of the various sections of the concrete experiments. The compressive strengths of the two types of cores are approximately the same and consequently are not indicative of the true condition of the pavement.

THE UPPER PICTURE SHOWS CORES TAKEN FROM THE CONCRETE SECTIONS AND THE TWO LOWER PICTURES SHOW CORES FROM THE BRICK SECTIONS

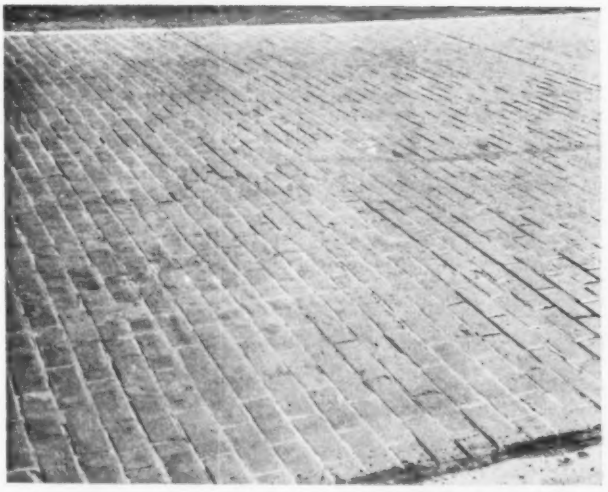
Sections K, L, M and part of N were constructed over a heavy fill which some years ago settled to a considerable extent, causing failures in the overlying pavement necessitating heavy repair during 1919, 1920, and 1922. The cost of such repair is not properly chargeable to surface maintenance and therefore has not been included in the accumulated cost data of Figure 2 and Table 1. A foundation failure occurred also at the junction of this experiment and the adjoining concrete pavement. This was apparently due to expansion of the concrete, and the brick on a strip 2 feet wide across the section are cracked and worn. The brick of section N are rough and badly broken.

CONDITION OF BRICK SECTIONS IN 1928

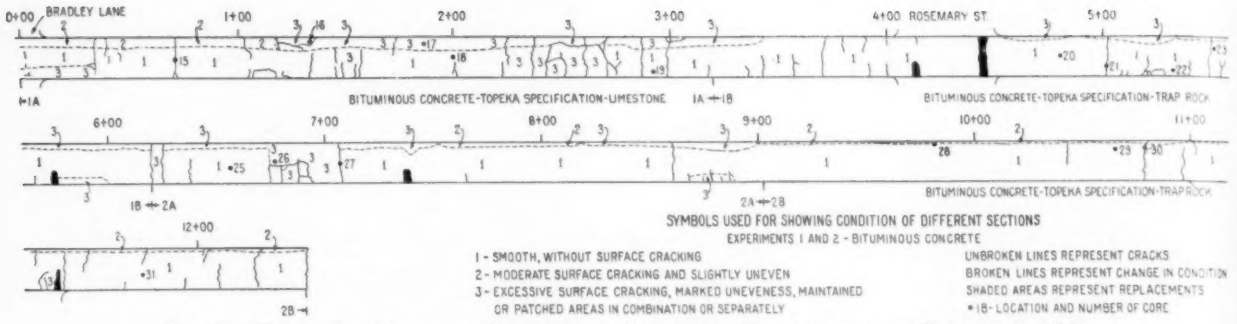
FIG. 3.—CONDITION CHART OF BITUMINOUS CONCRETE EXPERIMENTS IN FEBRUARY, 1928

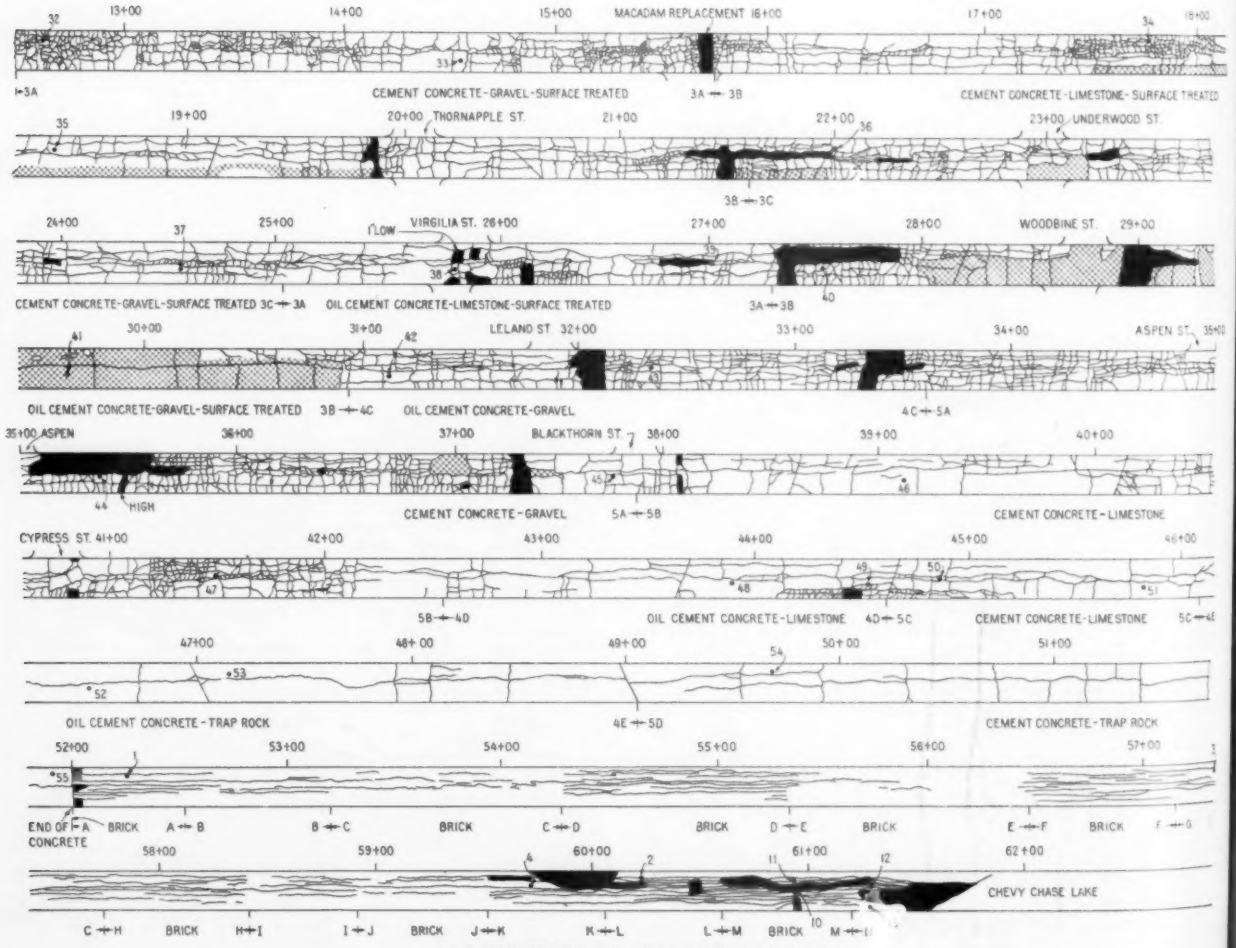
FIG. 4.—CONDITION CHART OF CEMENT CONCRETE AND BRICK EXPERIMENTS IN FEBRUARY, 1928
